Revision Guide for AMD Family 10h Processors

Publication # 41322	Revision: 3.92
Issue Date: March 2012

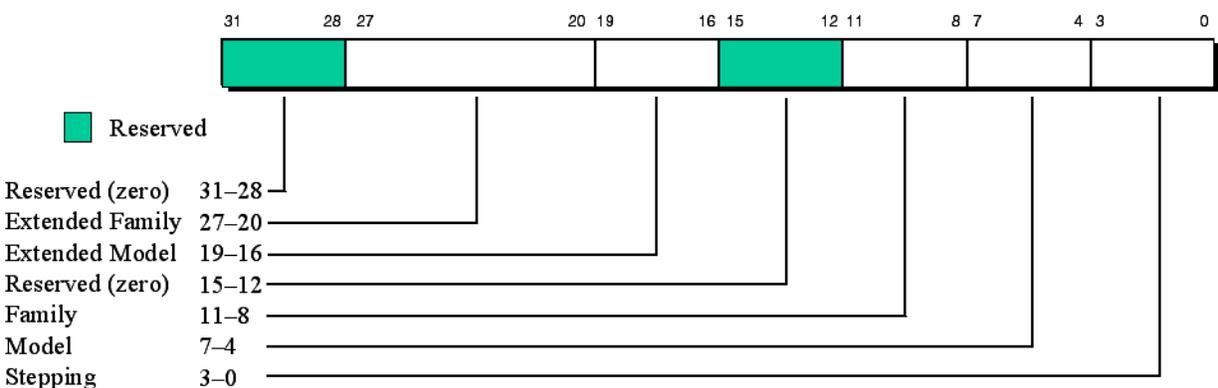
Figure 1. Format of CPUID Fn0000_0001_EAX

A processor revision is identified using a unique value that is returned in the EAX register after executing the CPUID instruction function 0000_0001h (CPUID Fn0000_0001_EAX). Figure 1 shows the format of the value from CPUID Fn0000_0001_EAX. In some cases, two or more processor revisions may exist within a stepping of a processor family and are identified by a unique value in F4x164 Fixed Errata Register (see page 26).
