# Revision Guide for AMD Family 17h Models 00h-0Fh Processors

Publication # <b>55449</b>	Revision: <b>1.12</b>
Issue Date: <b>June 2018</b>

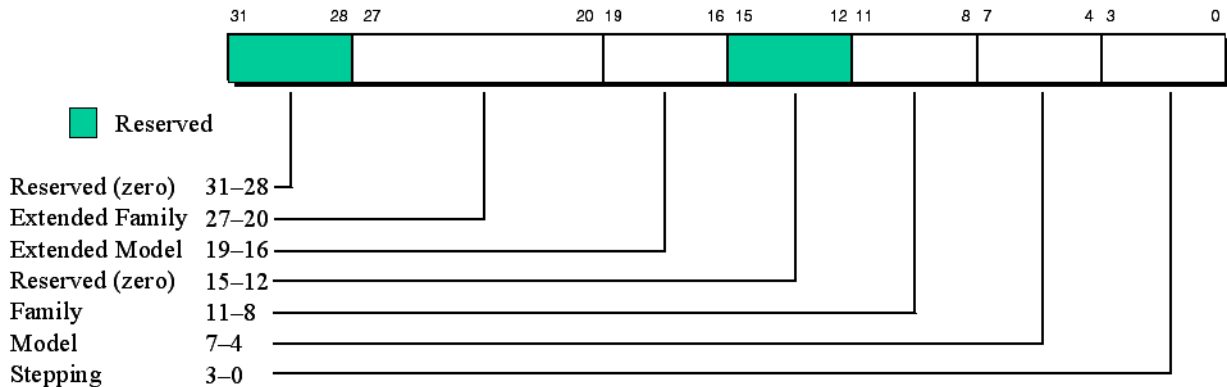
A processor revision is identified using a unique value that is returned in the EAX register after executing the CPUID instruction function 0000\_0001h (CPUID Fn0000\_0001\_EAX).

Figure 1. Format of CPUID Fn0000\_0001\_EAX

The following tables show the identification numbers from CPUID Fn0000\_0001\_EAX for each revision of the processor to each processor segment. "X" signifies that the revision has been used in the processor segment. "N/A" signifies that the revision has not been used in the processor segment.
