Revision Guide for AMD Family 17h Models 30h-3Fh Processors

Publication # 56323	Revision: 0.78
Issue Date: March 2021

Advanced Micro Devices

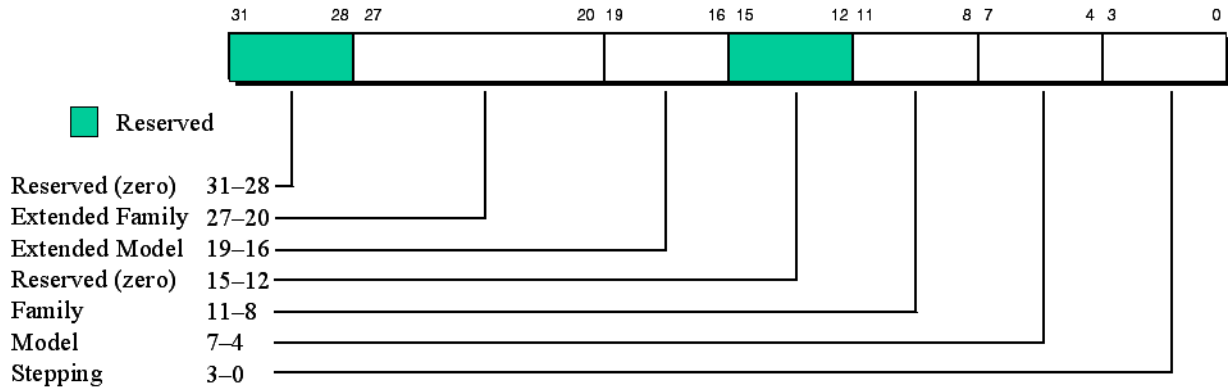
Figure 1. Format of CPUID Fn0000_0001_EAX

A processor revision is identified using a unique value that is returned in the EAX register after executing the CPUID instruction function 0000_0001h (CPUID Fn0000_0001_EAX). Figure 1 shows the format of the value from CPUID Fn0000_0001_EAX.
