# Revision Guide for AMD Family 15h Models 10h-1Fh Processors

Publication # <b>48931</b>	Revision: <b>3.10</b>
Issue Date: <b>May 2013</b>

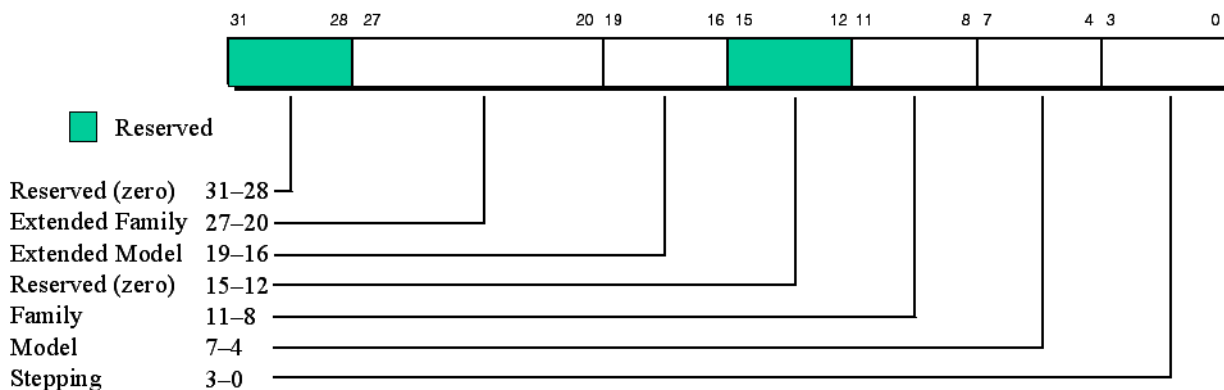
**Figure 1. Format of CUID Fn0000\_0001\_EAX**

A processor revision is identified using a unique value that is returned in the EAX register after executing the CUID instruction function 0000\_0001h (CUID Fn0000\_0001\_EAX). [Figure 1](#) shows the format of the value from CUID Fn0000\_0001\_EAX. In some cases, two or more processor revisions may exist within a stepping of a processor family and are identified by a unique value in D18F4x164 Fixed Errata Register (see [D18F4x164 Fixed Errata Register](#)).
