Revision Guide for AMD Family 17h Models 30h-3Fh Processors

Publication # 56323	Revision: 0.74
Issue Date: September 2019

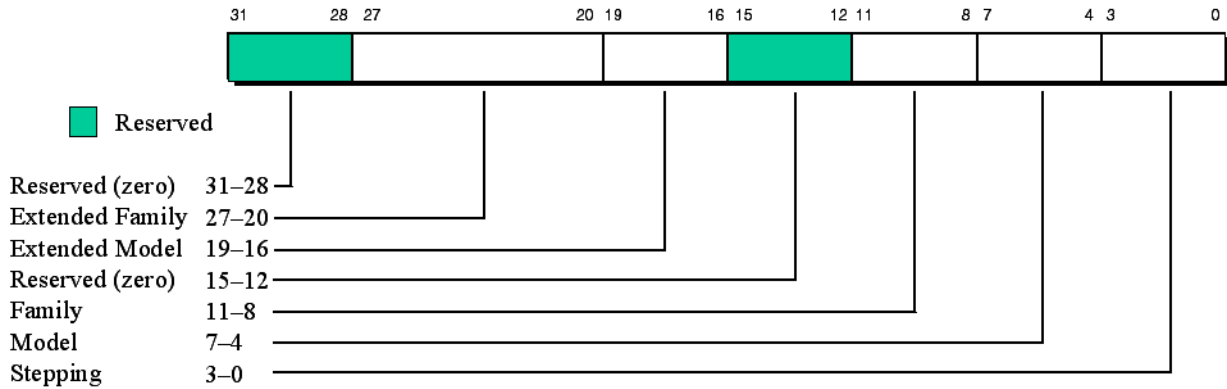
Figure 1. Format of CPUID Fn0000_0001_EAX

A processor revision is identified using a unique value that is returned in the EAX register after executing the CPUID instruction function 0000_0001h (CPUID Fn0000_0001_EAX). Figure 1 shows the format of the value from CPUID Fn0000_0001_EAX.
